CAVITATION AND HYDROABRASIVE RESISTANCE OF METALS IN HYDRAULIC TURBINES

CAVITATION AND HYDROABRASIVE RESIS-
TANCE OF METALS IN HYDRAULIC TURBINES
(Selected Articles)

Source: Kavitatsiya i Gidroshli-
fuyushchaya Stoykost' Metallov
v Gidravlisheskikh Turbinakh,
1965, pp. 95-104.

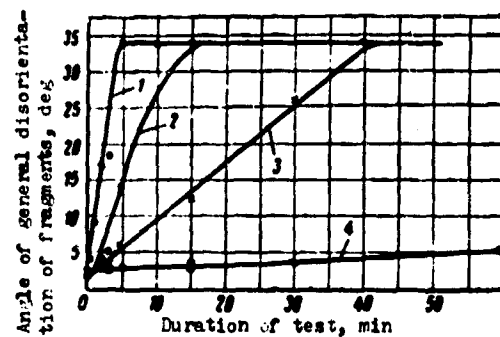
Fig. 1. Angle of general disorientation of fragments of α -phase of bronze Br A4 (1), Br A8 (2), Br A12 (3) α - and β - phases of bronze Br A12 (4) depending upon the duration of the cavitation test.

During the incubation period, microvolumes of the alloy with dimensions of 10⁻³ mm experienced plastic deformation, which leads to the development of surface relief which is accompanied by distortion of the crystal lattice of a second kind, splitting of blocks of the mosaic, and general disorientation of fragments (Fig. 1), the appearance of slip lines and microdents, and growth in values of microhardness.

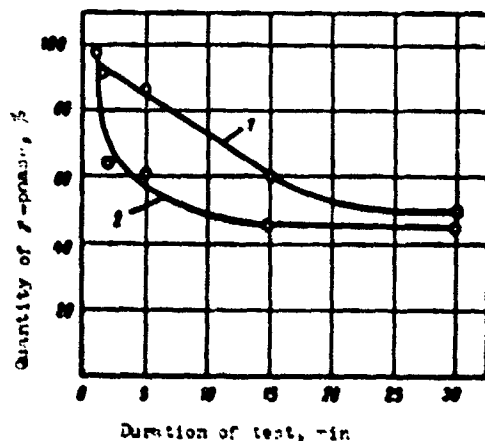
Fig. 2. Quantity of γ -phase in a cavitated layer of annealed (1) and hardened (2) steel 1Kh18N9T depending upon the duration of cavitation testing.

Along with these changes of the surface layer characteristic for all the investigated materials, in certain groups of alloys special phenomena are observed. Thus, in fine-grained materials (dimension of grain less than $3-5 \mu$) there is revealed a selective destruction of crystallites unfavorably oriented with respect to operational loads. In unbalanced alloys (hardened perlite steels and unstable austenitic steels) the mechanical and thermal effect of the cavitation zone causes phase transitions - tempering, transition of γ -phase to α -phase (Fig. 2).
